# Manhole Inspection Summary

Manhole # S35MM\_045MH

Insp Date: **3/6/07 11:45 AM**

**Location** Address: **102 22ND ST**

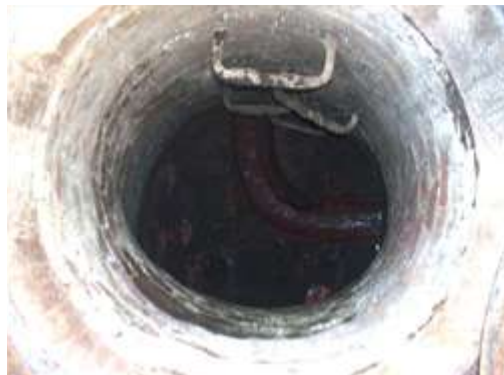
Top View

**Steps** Count: **4** Missing: **0** ☒ **Corroded**

**Surcharge** ☒ **Evidence Of Surcharge** Depth: **4.5** (ft.) ☐ Active Surcharge Present

Corroded steps. Evidence of surcharge - Bench debris.

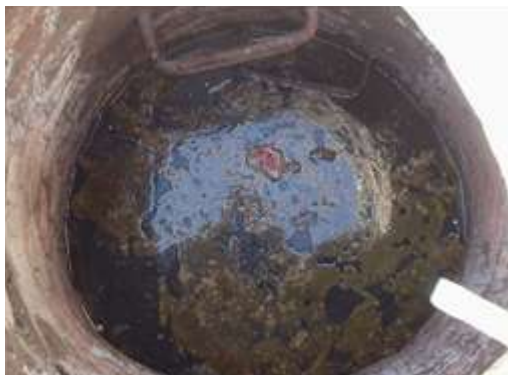
Top View

Surcharge - 1st visit.

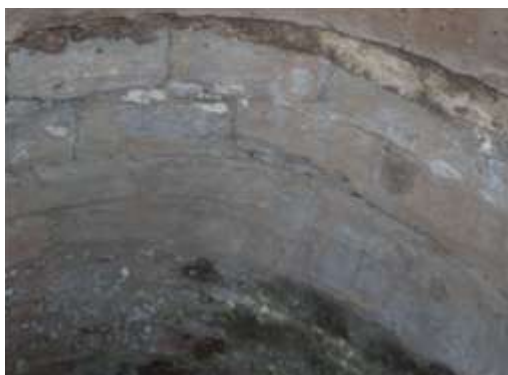
Defect

☒ **Leaks**

Condition: ☐ Sound ☐ Cracked ☐ Root Intrusion ☐ Loose Brick ☒ **Deteriorated**

Infiltration: ☐ None ☒ **Joint** ☐ Cracks ☐ Mortar ☐ Roots ☒ **Wall**

Infiltration: ☐ None ☐ Joint ☐ Cracks ☐ Mortar ☐ Roots ☒ **Wall**

Frame leaks. Corbel deterioration and infiltration. Barrel infiltration.
